PASSIVE RETROFIT

EMERGES FROM ASHES OF 80s BUNGALOW

If you've ever wanted to take a passive house for a road test, one holiday letting on the coast of west Cork may be too good an opportunity to turn down. The aptly named Sea Spray – an as yet uncertified Enerphit upgraded bungalow – is a bona fide triumph in the face of adversity.

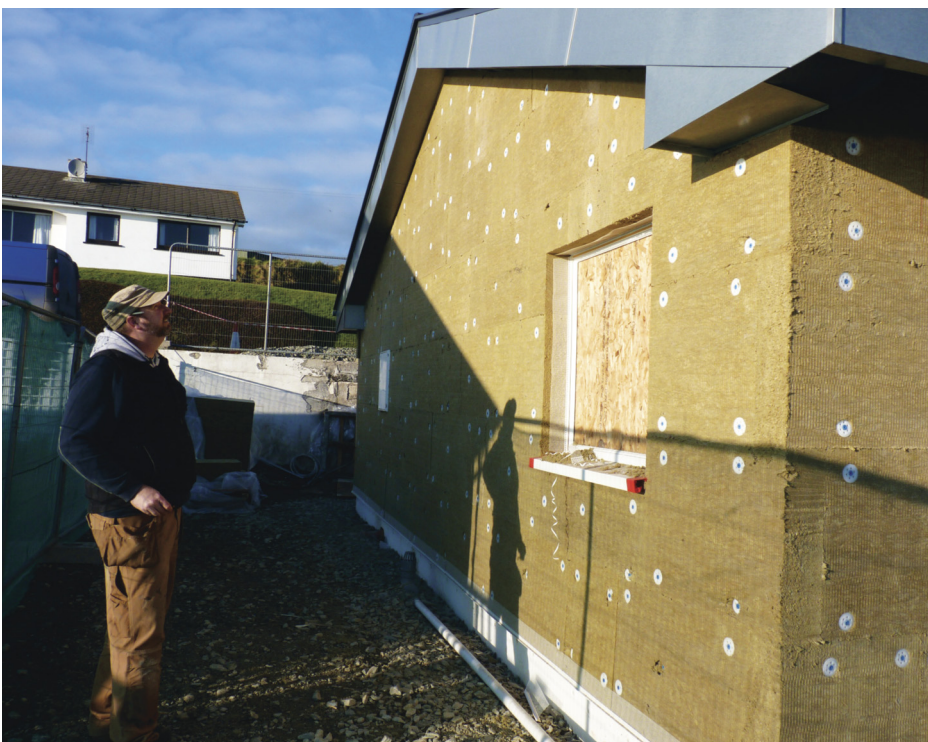
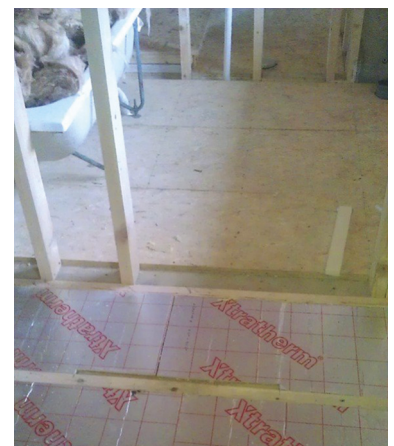
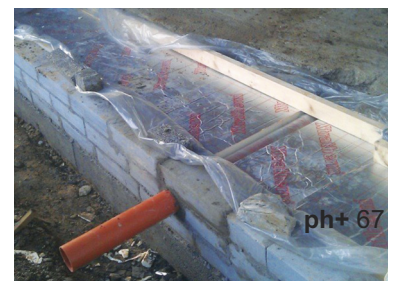
(p67, clockwise from top) Builder Tim O'Donovan and client Doris Knoebel; height restrictions meant only 50mm of Xtratherm insulation could be installed in the floor; the door threshold was brought forward with thermal blocks and an external air feed pipe fitted for the stove; the walls are externally insulated with 150mm of Rockwool.
